Manhole Inspection Summary

Manhole # S43EE_009MH

Insp Date: **7/7/09 2:31 PM**

Location Address: **1722 CHASE ST** Cross Street: **MCDONOGH ST**

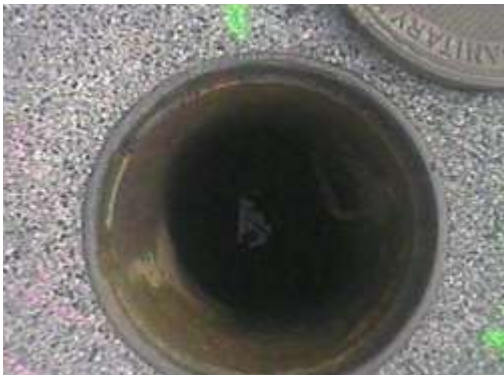
Defect 1

Steps Count: **4** Missing: **0** ☒ **Corroded**

corroded steps

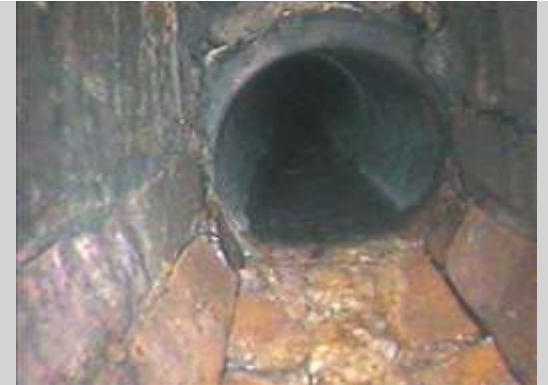
12 O'Clock Outflow

8 in. Circular Gravity Sewer
Pipe Out @ 12 O'Clock

Pipe Height: (in.) Direct
Pipe Material: **Clay** ☐ Pipe Lined
Invert Depth: **9.27** (ft.) Flow Characteristics: **Fast**
Deposits: ☒ None ☐ **Mud** ☐ **Sludgy** ☐ Debris ☐ Grease
Silt Depth: (in.) Deposits Extent:
Infiltration: **None** Pipe Seal Cond: **Sound**

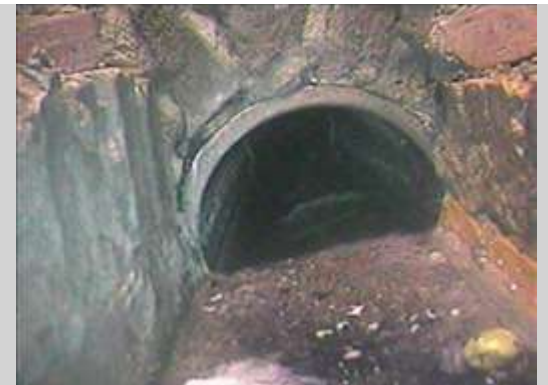
6 O'Clock Inflow

8 in. Circular Gravity Sewer
Pipe In @ 6 O'Clock

Pipe Height: (in.) Direct
Pipe Material: **Clay** ☐ Pipe Lined
Invert Depth: **9.15** (ft.) Flow Characteristics: **Slow**
Deposits: ☐ None ☒ **Mud** ☒ **Sludgy** ☐ Debris ☐ Grease
Silt Depth: **2** (in.) Deposits Extent: **Light**
Infiltration: **None** Pipe Seal Cond: **Sound**
